The Demise of The Bolsover Tunnel by Derek Grindell

This is an edited version of an article by Derek Grindell in the North East Derbyshire Industrial Archaeological Society Journal, Volume 2, 2008.

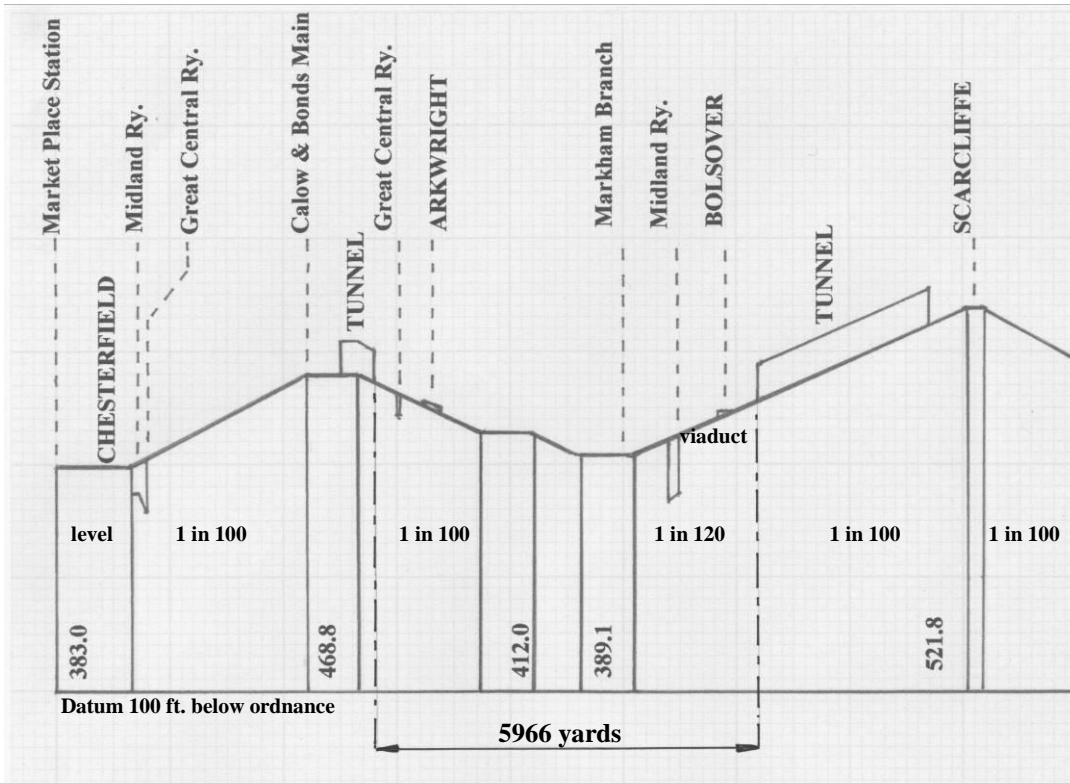
Fig. 3 A diagram of the gradients encountered by the LD&ECR between Chesterfield and Scarcliffe. The Duckmanton Tunnel at a length of 501 yards was dwarfed by the Bolsover Tunnel, which extended in virtually a straight line for a distance of 2624 yards.

the River Rother, the Midland Railway's main line, the GCR's Chesterfield Loop and the main Derby Road on a 700ft. viaduct. Thereafter a 1 in 100 incline over 2 miles took the line to a tunnel at Bolehill, some 630 yards due south of the main road through Duckmanton. After 501 yards the line emerged into a cutting, crossing under the GCR's Sheffield-Annesley line and through Arkwright Town Station, which was located 3¼ miles from the

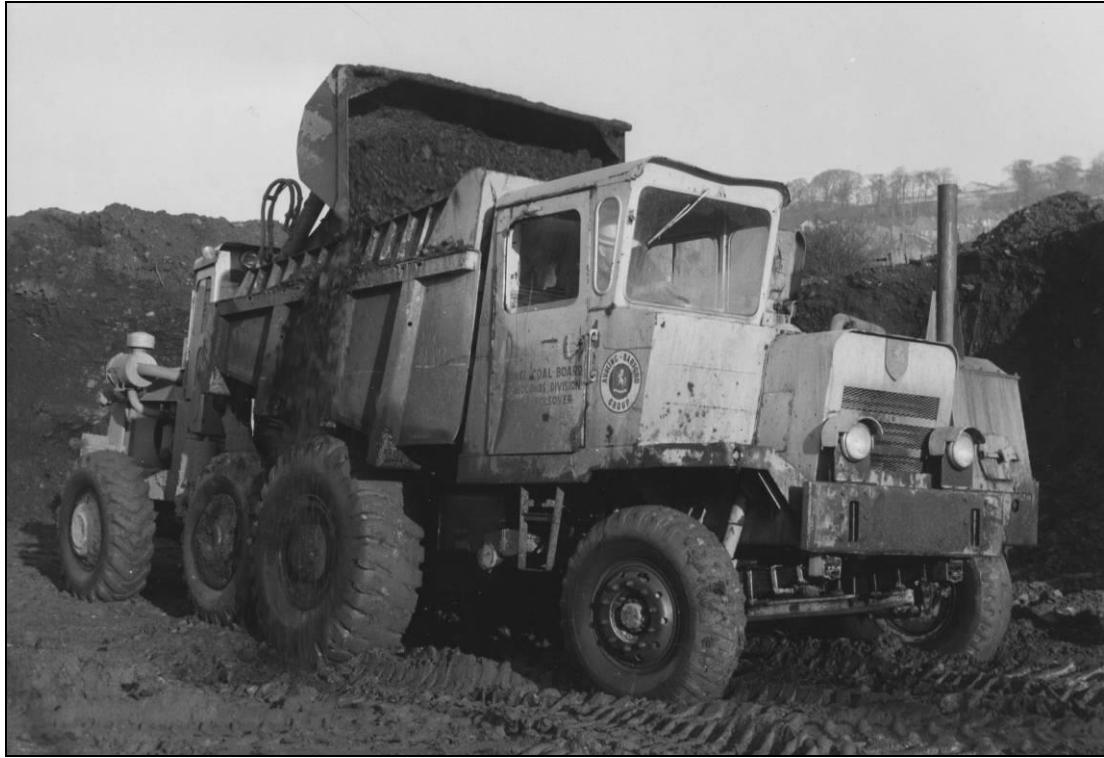
Fig. 5 Aveling-Barford's Type SL.300 Dumptruck being loaded.

The *Aveling-Barford News* (Vol.5 No.12, April 1967), house journal of the Aveling-Barford Group, featured an account of the measures taken to comply with an agreement reached between the NCB and BR that the Bolsover Tunnel should be infilled. It was estimated that this would require 150,000 cubic yards of 'run-of-mine dirt' to be hauled by road from Bolsover Colliery to a stockpile about 900 yards from the tunnel entrance. The NCB's Civil Engineering Department was authorised to undertake the task and work started on 10th October 1966 with two Aveling-Barford SL.300 Dumptrucks (see Fig. 5) fitted with Leyland engines deployed on moving the spoil. Initially the laden haul was in excess of 2,400 yards and heavy rainfall had softened the ground on the approach to the entrance although generally conditions varied from extremely wet to reasonably dry. Each vehicle delivered 12 tons up a slight adverse gradient but, once the tunnel was entered, total darkness prevailed and the drivers were entirely reliant on their own lights. The cumulative effect of locomotive smoke stacks over the years had endowed the brick lining with a generous coating of soot and even the less affected walls had no reflective properties. At various points in the tunnel cascades of water seeped through the roof, ensuring that the unmetalled track bed remained immersed to depths ranging from one inch to two feet.

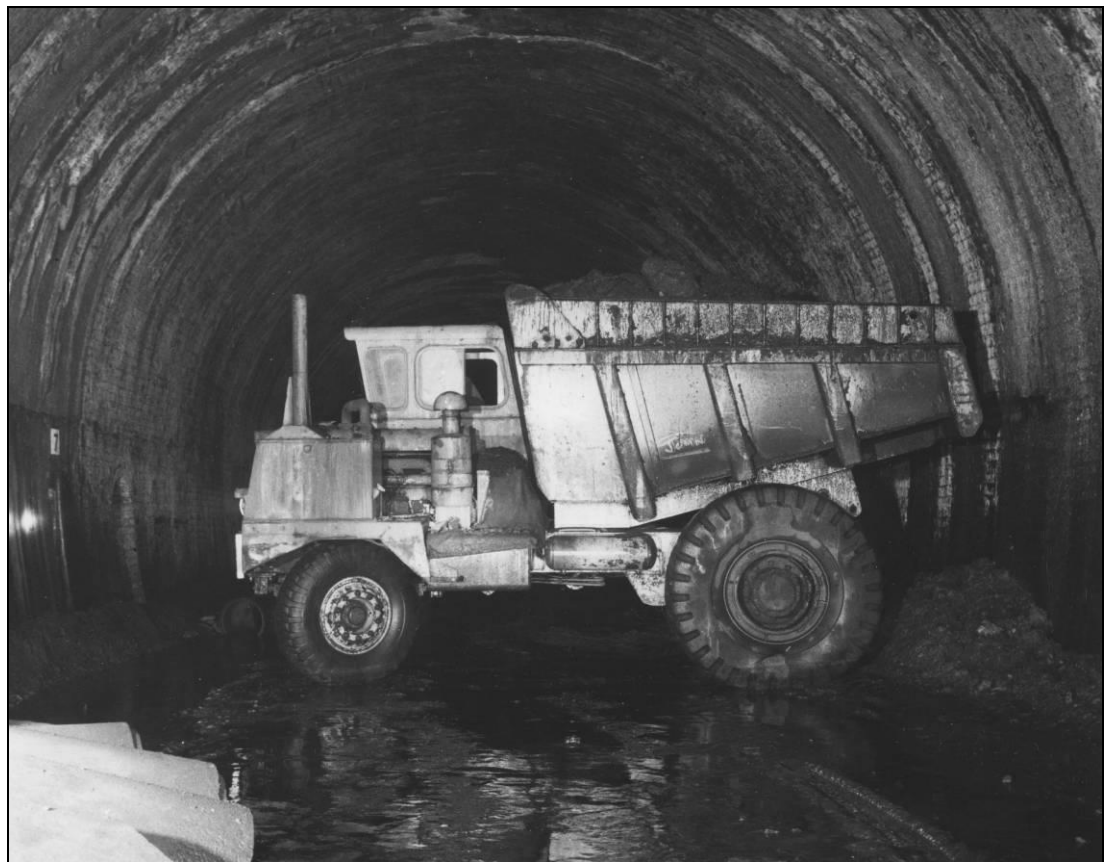
Fig. 6 The SL Dumptruck manoeuvring to approach the tipping area.

At the initial stages of the infill project the dumptrucks were driven into the tunnel in the forward position to within about fifty yards of the fill area. They were then turned round, reversed up to the fill point, tipped and driven out, a routine that achieved a saving of three minutes on the cycle. With a turning circle of only 23' 6" it was possible to turn the SLs around with a minimum of shunting although, at the centre of the turn, the clearance at either end of the dumptruck was only one yard. When the tunnel had been significantly shortened it was anticipated that further economies would be achieved by using two-way steering and controls on the SLs. The second SL followed the first after an interval of two minutes. Both drove on the right but on approaching the fill area the second dumptrack moved to the left side waited for the first to tip and drive away. The second turned and reversed to the fill area, tipped and followed the first out of the tunnel, both using the same side as that used for the inward journey. A combination of skilful driving and strict observation of a mutually agreed safety code enabled the dumptruck operators to complete a fill cycle in 25 minutes. Each day 17 trips were made, which resulted in a the delivery of more than 400 tons of fill. Whilst the dumptrucks were en route for another load, a tracked bucket excavator compacted the fill material into position, filling all but the top three feet of tunnel head, which was left

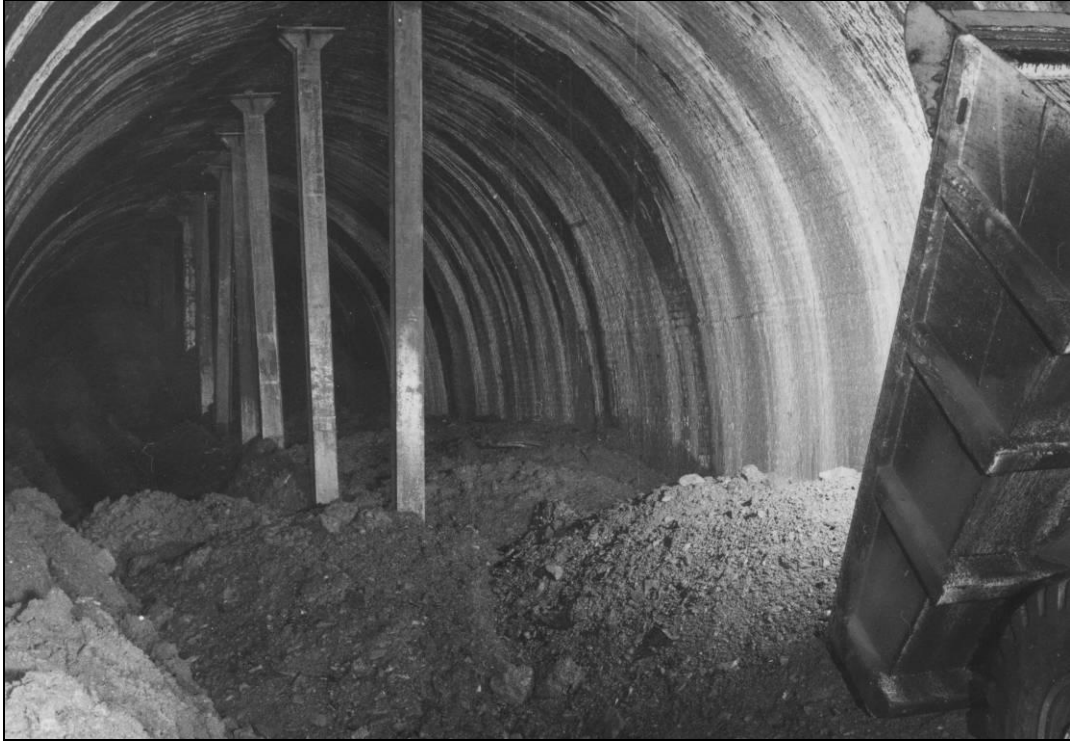
Fig. 7 A load of ‘run-of-mine dirt’ being tipped prior to the arrival of the excavator.

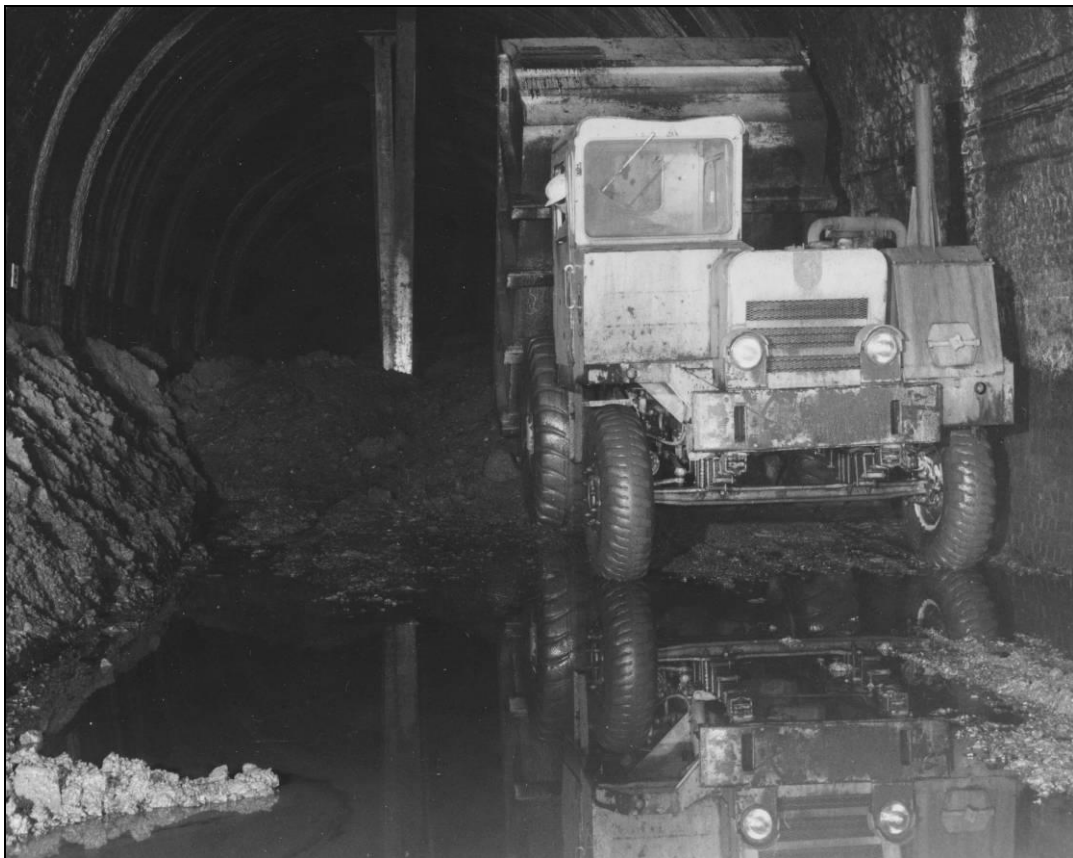
Fig. 8 Reflections in a tunnel. The SL Dumptruck completing tipping and in position to leave the tunnel.
